Building Information - Worthington City (45138) - Slate Hill Elementary

Program Type	Classroom Facilities Assistance Program (CFAP) - Regular
Setting	Suburban
Assessment Name	Slate Hill Elementary School 110460 FINAL
Assessment Date (on-site; non-EEA)	2025-10-08
Kitchen Type	Warming Kitchen
Cost Set:	2025
Building Name	Slate Hill Elementary
Building IRN	110460
Building Address	7625 Alta View Blvd
Building City	Worthington
Building Zipcode	43085
Building Phone	(614) 450-5000
Acreage	16.28
Current Grades:	K-5
Teaching Stations	30
Number of Floors	1
Student Capacity	684
Current Enrollment	493
Enrollment Date	2025-08-04

Building Pictures - Worthington City(45138) - Slate Hill Elementary(110460)

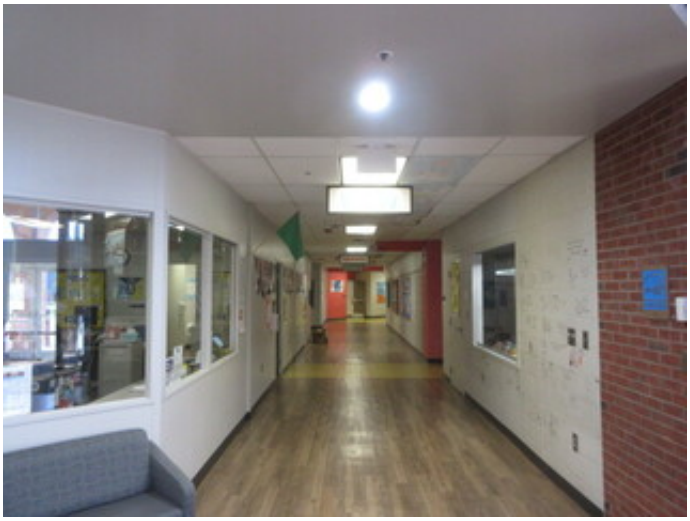
Description: Daylighting strategies, complemented with photo-cell control of lighting fixtures are currently featured in the building's design. The typical Classrooms in the overall facility are equipped with T-8 2x4 lay-in fluorescent fixtures with dual level switching. Classroom fixtures are in good condition, providing an average illumination of 37 FC, which is less than the 40 FC recommended by the OSDM. The Art Room in the overall facility is equipped with T-8 2x4 lay-in fluorescent fixtures with dual level switching as well as 1x4 indirect suspended fluorescent fixtures with dual level switching. Art room fixtures are in good condition, providing an average illumination of 41 FC, thus complying with the 40 FC recommended by the OSDM. The Typical Corridors in the overall facility are equipped with T-8 2x4 lay-in fluorescent fixtures with dual level switching as well as T-8 recessed can fixtures with single level switching. Corridor fixtures are in good condition, providing an average illumination of 14 FC which is less than the 15 FC recommended by the OSDM. The Primary Gymnasium spaces are equipped with T-8 suspended fluorescent fixtures type lighting, in good condition, providing an average illumination of 36 FC, thus complying with the 30 ES FC recommended by the OSDM. The Media Center is equipped with T-8 lay-in fluorescent fixture type lighting in good condition, providing an average illumination of 36 FC, thus complying with the 30 FC recommended by the OSDM. The Student Dining spaces are equipped with T-8 2x4 lay-in fluorescent fixture type lighting with multi level switching. Student Dining fixtures are in good condition, providing an average illumination of 25 FC, which is less than the 40 FC recommended by the OSDM. The Kitchen spaces are equipped with T-8 1x4 surface mounted fluorescent fixture type lighting with multi level switching. Kitchen fixtures are in good condition, providing an average illumination of 54 FC, which is less than the 50 FC recommended by the OSDM. The Service Areas in the overall facility are equipped with T-8 1x4 suspended fluorescent fixture type lighting in good condition. The Typical Administrative spaces in the overall facility are equipped with T-8 2x4 lay-in fluorescent fixture type lighting in good condition, providing inadequate illumination based on OSDM requirements. The overall lighting systems of the facility are not fully compliant with Ohio School Design Manual requirements due to inadequate lighting levels.

Recommendations: Provide complete replacement of interior lighting system due to lighting levels, installation of systems outlined in Items A, C, D, E, T, U.

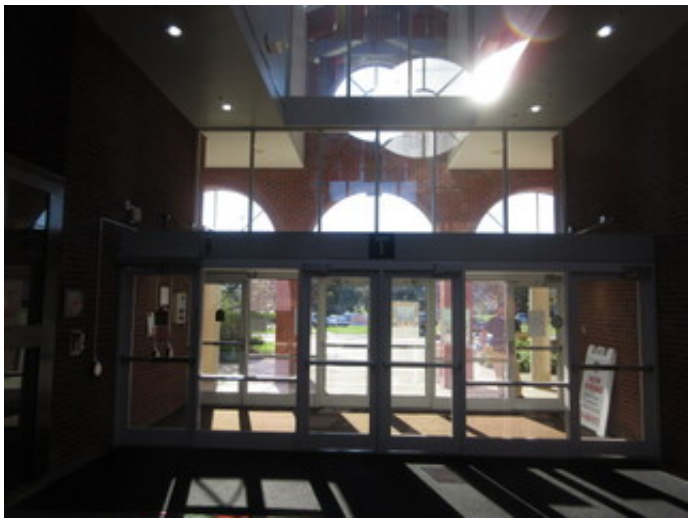
Description: The overall facility contains a Habitec motion detector / CCTV / intrusion type security system in fair to good condition. Motion detectors are adequately provided at main entries, central gathering areas, office, main Corridors, and spaces where 6 or more computers are located. Exterior doors are equipped with door contacts. An automatic visitor control system is provided. Administrative offices are located adjacent to the Main Entrance to the facility, an a secure entrance vestibule is provided. Compliant color CCTV cameras are provided at main entry areas, parking lots, central gathering areas, and main Corridors. CCTV is monitored in Administrative Areas with the use of a TV / LCD monitor. A compliant computer controlled access control system integrating alarms and video signals, with appropriate UPS backup, is not provided. The system is equipped with card/fob readers. The system is not equipped with panic alarms. The system is not equipped with lockdown capabilities. The security system is adequately provided throughout, and the system is not fully compliant with Ohio School Design Manual guidelines. The playground at the overall facility is currently not enclosed with fencing and is open to adjacent sports fields, asphalt sports courts and parking lot. The exterior site lighting system is equipped with recessed and surface mounted metal halide entry lights in poor to fair condition. Pedestrian walkways are illuminated with five fixtures in poor to fair condition. Parking and bus pick-up / drop off areas are illuminated by pole mounted metal halide fixtures in fair condition. The exterior sight lighting provides inadequate illumination due to insufficient fixture capacity, sparse placement of fixtures and age / condition of fixtures.

Secured Vestibule Main Entrance

Habitec Security Panel in Vestibule

Recommendations: Provide complete replacement of security system to meet Ohio School Design Manual guidelines.

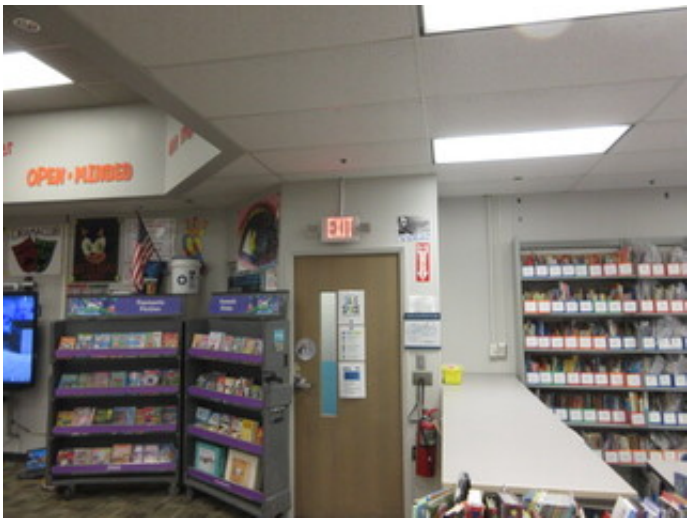
Description: The overall facility is equipped with an emergency egress lighting system consisting of non compliant incandescent, plastic construction exit signs, as well as OSDM compliant red lettered exit signs, and the system is in fair condition. The facility is inadequately equipped with emergency egress floodlighting, and the system is in fair condition. The system is provided with appropriate battery back up emergency generator. The system is not adequately provided throughout, and does not meet Ohio School Design Manual and Ohio Building Code requirements.

Plastic Construction Exit Signage with no Egress Lighting at exits

Exit Sign and Egress Lighting in Media Center

Recommendations: Provide complete replacement of emergency / egress lighting system to meet Ohio School Design Manual and Ohio Building Code guidelines.

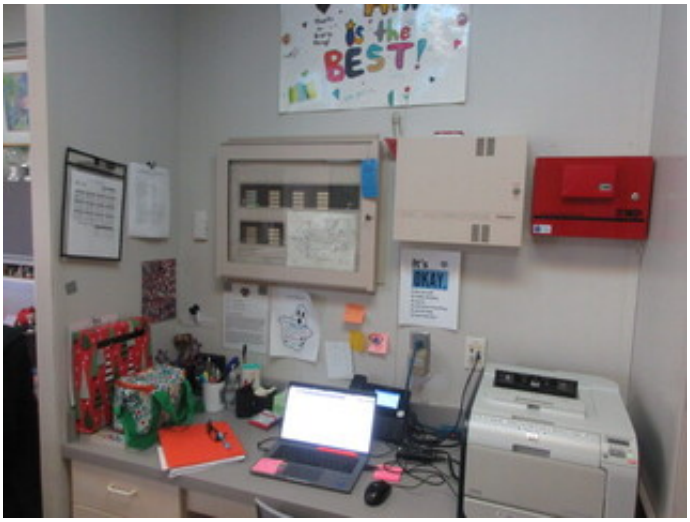
Description: The overall facility is equipped with a Simplex 4000 series type fire alarm system installed in 1989, and in fair condition, consisting of manual pull stations, bells, horn and strobe indicating devices. The system is addressable. The main control panel is located in the administrative area. Remote annunciators are provided at main entries. The system is automatic and is not remotely monitored by a third party. The fire alarm system is not connected to an automatic digital communicator that is monitored by a central station. The system is not equipped with connected door hold-open devices, controlled by smoke detectors at doors. The system is adequately equipped with both primary and secondary compliant power sources. The system is equipped with sufficient audible horns, strobe indicating devices and smoke detectors. The system is not equipped with sufficient flow switches, tamper switches, and heat sensors. The system thus will not support future fire suppression systems. The system has sufficient expansion capabilities, with additional zone capabilities, to support the future needs of the school. The system appears to meet current code requirements. The system is not adequately provided throughout. The system is not fully compliant with Ohio Building Code, NFPA, ADA, and Ohio School Design Manual requirements.

Fire Protection panel in entry Vestibule

Main Fire Protection Panels in Admin Offices

Recommendations: Provide complete replacement of fire alarm system to meet OBC, NFPA, ADA, and Ohio School Design Manual guidelines.

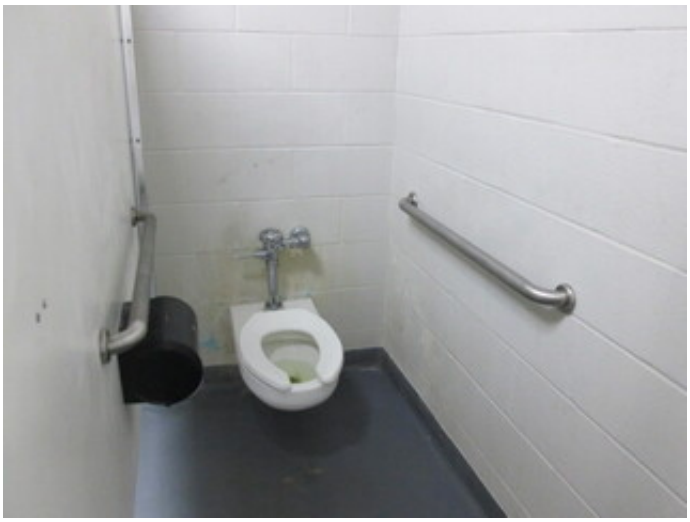
Staff Restroom

Typical ADA Stall

Recommendations: Provide ADA-compliant signage, 1 power assist door opener, 5 electric water coolers, 21 toilets, 21 sinks, 5 urinals, 21 toilet partitions, and toilet accessories in the overall facility to facilitate the school's meeting of ADA requirements. Provide remounting of mirrors to ADA height.

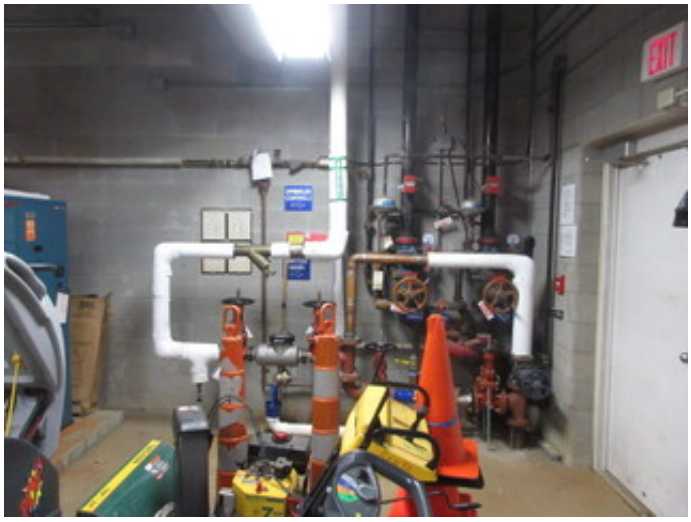
Description: The domestic water supply system is tied in to the municipal system, features a 3'' service and 3'' water meter, and is in good condition. The District was not able to provide water supply flow test data. The existing domestic water service does appear to meet the facility's current needs. The facility is equipped with an automated fire suppression system, for which the existing water supply provides adequate support. The domestic water service is equipped with a water booster pump, providing 15 psi, which is adequate and in good condition. The system provides adequate pressure and capacity for the future needs of the school.

Water Main and Fire Riser Assembly in Mech. Room

Water Main and Meter

Recommendations: Existing conditions require no renovation or replacement at the present time.

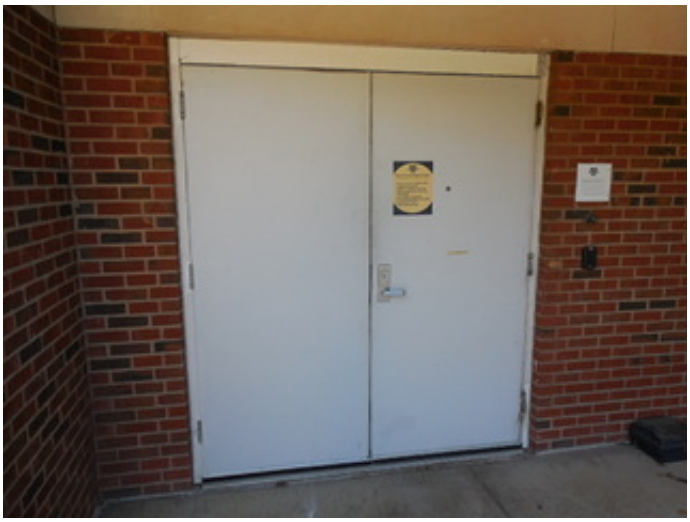
Description: Typical exterior doors in the overall facility are aluminum insulated panel type construction, installed on aluminum frames, and in fair condition. Typical exterior doors feature no vision panels, and appropriate hardware. Entrance doors in the overall facility are aluminum type construction, installed on aluminum frames, and in fair condition. Entrance doors feature single glazed tempered glass vision panels, transoms, sidelights, and appropriate hardware. The facility is equipped with one roof access door, in fair condition. There are no overhead doors in the facility.

Typical Entry Doors

Typical Exterior Doors

Recommendations: Replace all exterior doors due to age, condition, and to comply with Ohio School Design Manual guidelines.
