Building Information - Worthington City (45138) - Wilson Hill Elementary

Program Type	Classroom Facilities Assistance Program (CFAP) - Regular
Setting	Suburban
Assessment Name	Wilson Hill Elementary School 41624 FINAL
Assessment Date (on-site; non-EEA)	2025-10-09
Kitchen Type	Warming Kitchen
Cost Set:	2025
Building Name	Wilson Hill Elementary
Building IRN	41624
Building Address	6500 Northland Road
Building City	Worthington
Building Zipcode	43085
Building Phone	(614) 450-4800
Acreage	11.97
Current Grades:	K-5
Teaching Stations	34
Number of Floors	1
Student Capacity	561
Current Enrollment	537
Enrollment Date	2025-08-04

Building Pictures - Worthington City(45138) - Wilson Hill Elementary(41624)

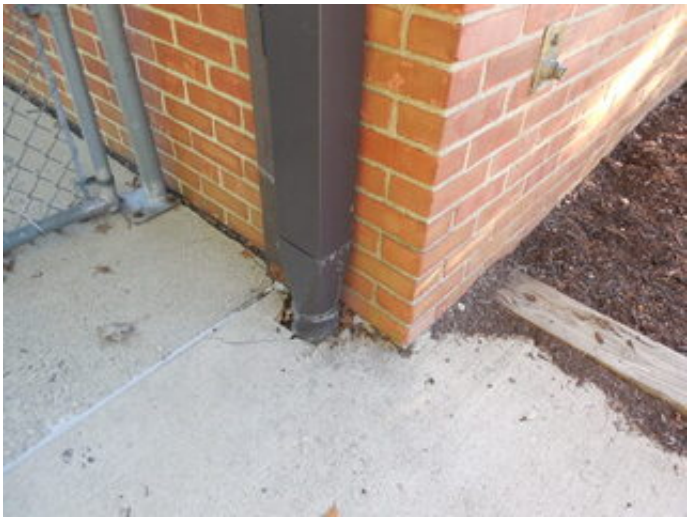
B. Roofing

Description: The roof over the overall facility is a EPDM system that was installed more than ten years ago and is in fair condition. There are no District reports of current leaking. No signs of past leaking were observed during the physical assessment. Access to the roof was gained by access hatch and access ladder that are in good condition. Fall safety protection cages are not required and are not provided. There were no observations of standing water on the roof. Metal cap flashings and stone copings are in fair condition. Roof storm drainage is addressed through a system of gutters and downspouts and roof drains, which are properly located, and in fair condition. Downspout boots are a component of the drainage systems and are in fair condition. The roof is not equipped with overflow roof drains though they will be required in areas of roof replacement. No problems requiring attention were encountered with any roof penetrations. There are not any covered walkways attached to this structure.

Rating: 3 Needs Replacement

Recommendations: The roof over the overall facility requires replacement to meet Ohio School Design Manual guidelines due to condition and age of system. Provide replacement of roof drains. Provide overflow roof drains. Provide replacement of gutters and downspouts. Provide replacement of metal cap flashing. Provide replacement of downspout boots.

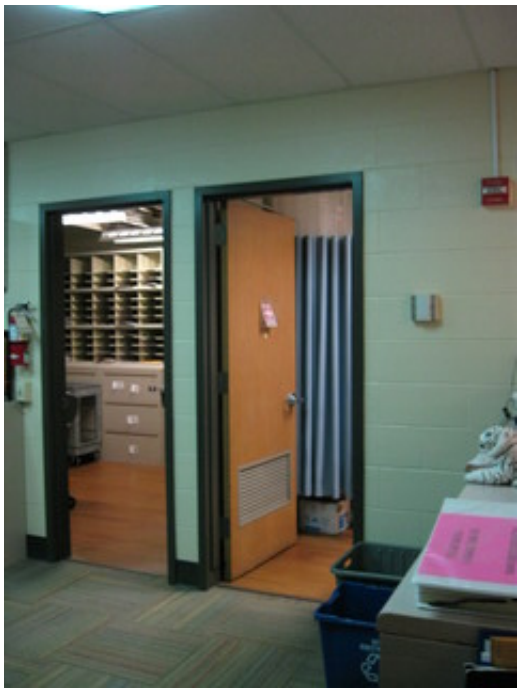
Rating: 3 Needs Replacement

Casework to be Replaced

Louvered Door to be Replaced

Recommendations: Provide for complete replacement of finishes and casework due to age and condition. Provide for replacement of interior doors due to age and condition. Provide for inadequate urinal screens. Provide for Gymnasium wall padding.

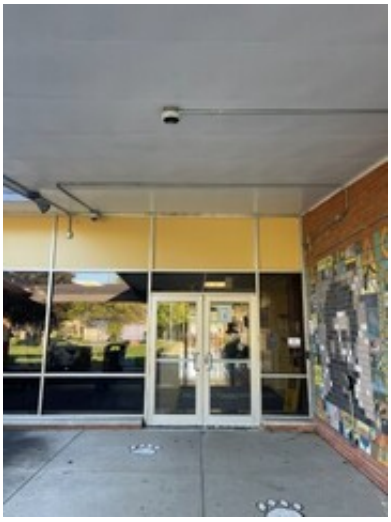
Description: The overall facility contains a Habitec Security motion detector / CCTV / intrusion type security system in fair to good condition. Motion detectors are adequately provided at main entries, central gathering areas, office, main Corridors, and spaces where 6 or more computers are located. Exterior doors are equipped with door contacts. An automatic visitor control system is provided. Administrative offices are not located adjacent to the Main Entrance to the facility, and a secure entrance vestibule is not provided. Compliant color CCTV cameras are minimally provided at main entry areas, and parking lots, central CCTV is monitored in Administrative Areas with the use of a TV / LCD monitor. A compliant computer controlled access control system integrating alarms and video signals, with appropriate UPS backup, is not provided. The system is equipped with card/fob readers. The system is not equipped with panic alarms. The system is not equipped with lockdown capabilities. The security system is inadequately provided throughout, and the system is not fully compliant with Ohio School Design Manual guidelines. The playground at the overall facility is currently not enclosed with fencing and is open to adjacent sports fields and asphalt sports courts. The exterior site lighting system is equipped with recessed and surface mounted high pressure sodium entry lights in poor to fair condition. Pedestrian walkways are illuminated with four fixtures in poor to fair condition. Parking and bus pick-up / drop off areas are minimally illuminated by pole mounted high pressure sodium fixtures in fair condition. The exterior sight lighting provides inadequate illumination due to insufficient fixture capacity, sparse placement of fixtures and age / condition of fixtures.

Rating: 3 Needs Replacement

Main Entry Lighting and Security Camera and Call box

Main Entry Interior - no Vestibule

Recommendations: Provide complete replacement of security system to meet Ohio School Design Manual guidelines.

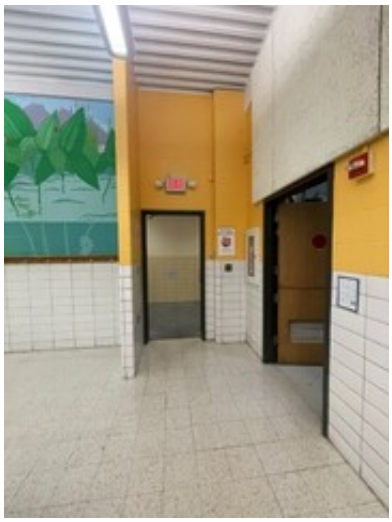
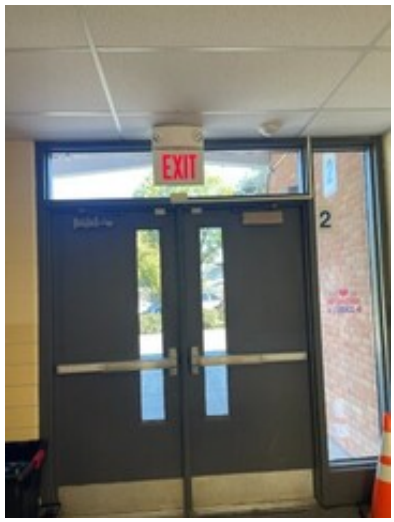
Description: The overall facility is equipped with an emergency egress lighting system consisting of non compliant plastic construction exit signs, as well as OSDM compliant red lettered, LED illuminated exit signs, and the system is in fair condition. The facility is inadequately equipped with emergency egress floodlighting, and the system is in fair condition. The system is not provided with appropriate battery back up or emergency generator. The system is not adequately provided throughout, and does not meet Ohio School Design Manual and Ohio Building Code requirements.

Rating: 3 Needs Replacement

Egress Flood Lighting located in Student Dining Space

Plastic Construction Exit Signs at Auxiliary Entrances

Recommendations: Provide complete replacement of emergency / egress lighting system to meet Ohio School Design Manual and Ohio Building Code guidelines.

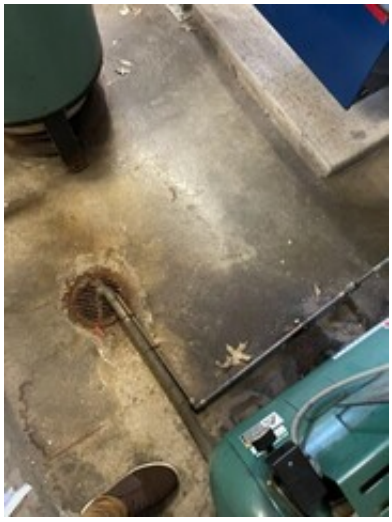
Description: The sanitary sewer system is tied in to the city system, and is in fair condition.

Storm Drains adequately placed in asphalt sports courts

Floor drain adjacent to Bryan Boiler in 1962 Original Construction

Recommendations: Existing conditions require no renovation or replacement at the present time.
