Building Information - Worthington City (45138) - Granby Elementary School

Program Type	Classroom Facilities Assistance Program (CFAP) - Regular
Setting	Suburban
Assessment Name	Granby Elementary School 98079 FINAL
Assessment Date (on-site; non-EEA)	2025-10-23
Kitchen Type	Warming Kitchen
Cost Set:	2025
Building Name	Granby Elementary School
Building IRN	98079
Building Address	1490 Hard Rd
Building City	Columbus
Building Zipcode	43235
Building Phone	614-450-4500
Acreage	38.38
Current Grades:	K-5
Teaching Stations	18
Number of Floors	1
Student Capacity	466
Current Enrollment	482
Enrollment Date	2025-08-04

Building Pictures - Worthington City(45138) - Granby Elementary School(98079)

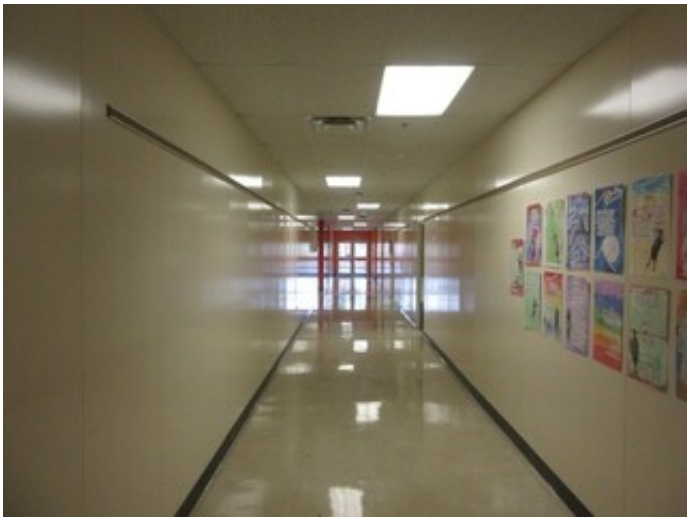
K. Interior Lighting

Description: Daylighting strategies, complemented with photo-cell control of lighting fixtures are currently featured in the building's design. The typical Classrooms in the overall facility are equipped with T-8 2x4 lay-in fluorescent fixture type lighting with multi level switching. Classroom fixtures are in fair condition, providing an average illumination of 37 FC, which is less than the 40 FC recommended by the OSDM. The typical Corridors in the overall facility are equipped with T-8 2x4 lay-in fluorescent fixtures with multi-level switching. Corridor fixtures are in good condition, providing an average illumination of 21 FC thus complying with the 15 FC recommended by the OSDM. The Primary Gymnasium spaces are equipped with T-8 2x4 suspended fluorescent fixtures type lighting, in good condition, providing an average illumination of 45 FC, thus complying with the 30 ES FC recommended by the OSDM. The Media Center is equipped with T-8 2x4 lay-in fluorescent fixtures fixture type lighting in good condition, providing an average illumination of 36 FC, thus complying with the 30 FC recommended by the OSDM. The Student Dining spaces are equipped with T-8 2x4 lay-in fluorescent fixture type lighting with multi level switching. Student Dining fixtures are in good condition, providing an average illumination of 32 FC, which is less than the 40 FC recommended by the OSDM. The Kitchen spaces are equipped with T-8 1x4 surface mounted fluorescent fixture type lighting with multi level switching. Kitchen fixtures are in good condition, providing an average illumination of 46 FC, which is less than the 50 FC recommended by the OSDM. The Service Areas in the overall facility are equipped with T-8 1x4 suspended fluorescent fixture type lighting in fair condition as well as T-8 2x4 lay-in fluorescent fixtures in good condition. The Typical Administrative spaces in the overall facility are equipped with T-8 2x4 lay-in fluorescent fixture type lighting in good condition, providing inadequate illumination based on OSDM requirements. The overall lighting systems of the facility are not fully compliant with Ohio School Design Manual requirements due to age and condition, inadequate lighting levels, and lack of LED fixtures.

Rating: 3 Needs Replacement

Recommendations: Provide complete replacement of interior lighting system due to condition, lighting levels, and lack of LED fixtures, installation of systems outlined in Items A, C, D, E, L, M, N, T, U, and W.

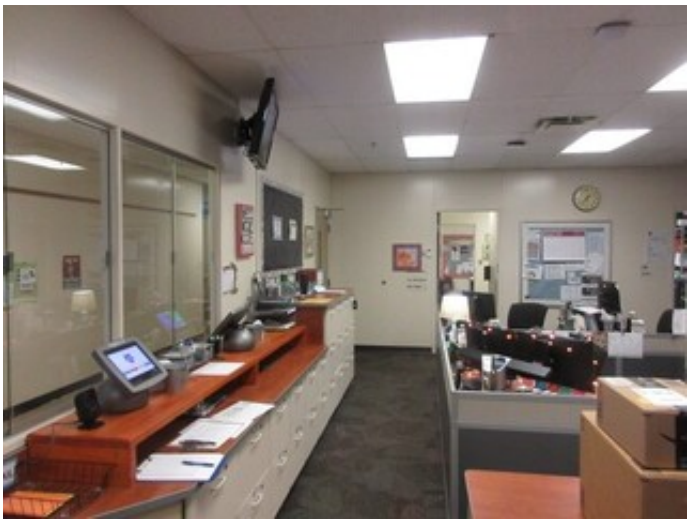
Description: The overall facility contains a Habitec motion detector / CCTV / intrusion type security system in fair to good condition. Motion detectors are adequately provided at main entries, central gathering areas, main corridors and offices. Exterior doors are equipped with door contacts. An automatic visitor control system is provided. Administrative offices are located adjacent to the Main Entrance to the facility, and a secure entrance vestibule is provided. Compliant color CCTV cameras are provided at main entry areas, and parking lots. CCTV is monitored in Administrative Areas with the use of a TV / LCD monitor. A compliant computer controlled access control system integrating alarms and video signals, with appropriate UPS backup, is not provided. The system is equipped with card/fob readers. The system is not equipped with panic alarms. The system is equipped with lockdown capabilities. The security system is inadequately provided throughout, and the system is not fully compliant with Ohio School Design Manual guidelines. The playground is not currently enclosed with fencing. The playground is open to asphalt sports courts, adjacent parking lots, and abutting residential neighborhood. The exterior site lighting system is equipped with recessed and surface mounted HID high pressure sodium entry lights in poor to fair condition. Pedestrian walkways are illuminated with three (3) fixtures in poor to fair condition. Parking and bus pick-up / drop off areas are illuminated by pole mounted fixtures. The exterior sight lighting provides inadequate illumination due to insufficient fixture capacity, sparse placement of fixtures, age and condition of fixtures.

Visitor Control Devices At Main Entry

Main Office Visitor Sign In And CCTV Monitor

Recommendations: Provide partial security system upgrades, consisting of complete replacement of exterior site lighting, panic alarms, additional CCTV cameras for central gathering areas and main corridors to meet Ohio School Design Manual guidelines.

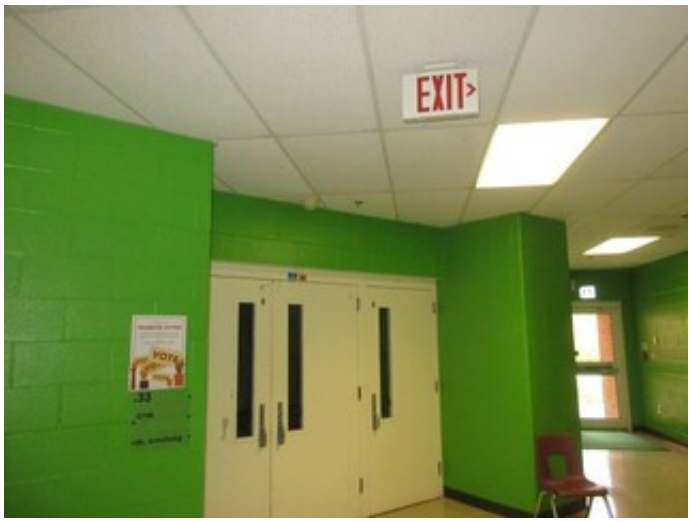
Description: The overall facility is equipped with an emergency egress lighting system consisting of non compliant incandescent, plastic construction exit signs, as well as OSDM compliant red lettered exit signs, and the system is in fair condition. The facility is inadequately equipped with emergency egress floodlighting, and the system is in poor condition. The system is provided with appropriate battery back up or emergency generator. The system is not adequately provided throughout, and does not meet Ohio School Design Manual and Ohio Building Code requirements.

Plastic Signage In Corridor

No Egress Lighting In Main Corridors

Recommendations: Provide complete replacement of emergency / egress lighting system to meet Ohio School Design Manual and Ohio Building Code guidelines.

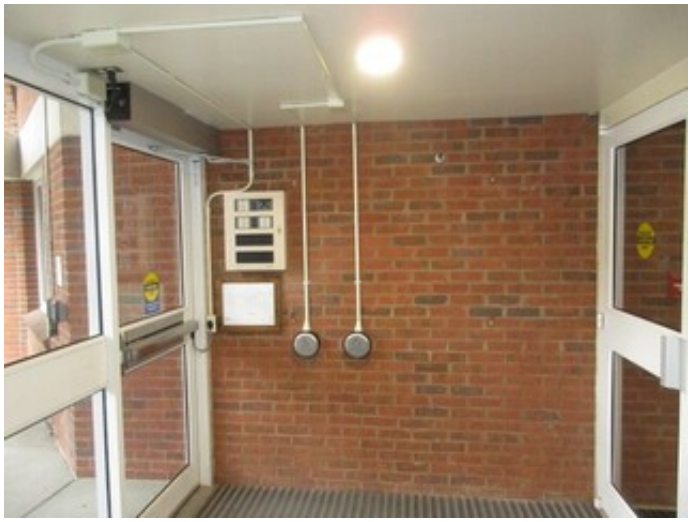
Description: The overall facility is equipped with a Simplex 4602 series type fire alarm system installed in 1988, and in fair condition, consisting of manual pull stations, bells, horn and strobe indicating devices. The system is addressable. The main control panel is located in the Administration Area. Remote annunciators are provided at main entries. The system is automatic and is remotely monitored by a third party. The fire alarm system is connected to an automatic digital communicator that is monitored by a central station. The system is not equipped with connected door hold-open devices, controlled by smoke detectors at doors. The system is adequately equipped with both primary and secondary compliant power sources. The system is equipped with sufficient audible horns, strobe indicating devices and smoke detectors. The system is not equipped with sufficient, flow switches, tamper switches, and heat sensors. The system thus will not support future fire suppression systems. The system does have sufficient expansion capabilities, with additional zone capabilities, to support the future needs of the school. The system appears to meet current code requirements. The system is inadequately provided throughout. The system is not fully compliant with Ohio Building Code, NFPA, ADA, and Ohio School Design Manual requirements.

Simplex 4602 Panel In Vestibule

Main Fire Alarm Panel In Administration Area

Recommendations: Provide complete replacement of fire alarm system to meet OBC, NFPA, ADA, and Ohio School Design Manual guidelines.

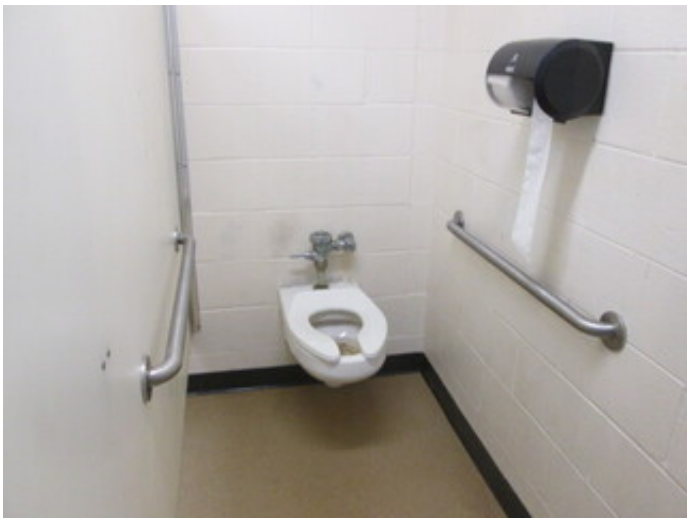
Typical Restroom Fixture

Stage Steps/Ramp

Recommendations: Provide ADA-compliant signage, 1 power assist door opener, 1 ramp, 1 electric water cooler, 14 toilets, 11 sinks, toilet partitions, toilet accessories, and exterior door hardware in the overall facility to facilitate the school's meeting of ADA requirements. Provide replacement of 3 sinks, 5 urinals and 4 electric water coolers. Provide replacement of 1 power assist door. Rework openings and Corridor walls for 11 doorways. Provide remounting of all mirrors.

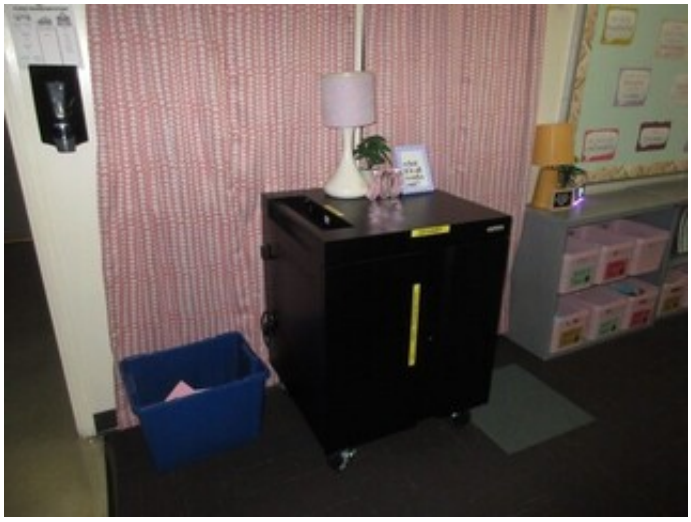
Mobile Technology Carts

Centralized Clock System

Recommendations: Provide complete replacement of technology systems to meet Ohio School Design Manual requirements, and to sustain the capacity to keep pace with technological development.
