Building Information - Worthington City (45138) - Worthington Park Elementary School

Program Type	Classroom Facilities Assistance Program (CFAP) - Regular
Setting	Suburban
Assessment Name	Worthington Park Elementary School 98087 FINAL
Assessment Date (on-site; non-EEA)	2025-10-08
Kitchen Type	Warming Kitchen
Cost Set:	2025
Building Name	Worthington Park Elementary School
Building IRN	98087
Building Address	500 Park Rd
Building City	Westerville
Building Zipcode	43081
Building Phone	614-450-5500
Acreage	18.14
Current Grades:	K-5
Teaching Stations	17
Number of Floors	1
Student Capacity	462
Current Enrollment	447
Enrollment Date	2025-08-04

Building Pictures - Worthington City(45138) - Worthington Park Elementary School(98087)

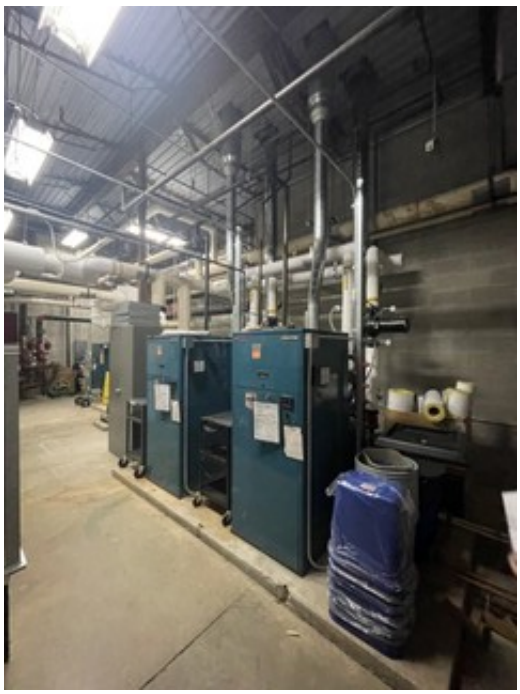
Description: The existing system for the overall facility is a natural gas fired heated water type boiler system, installed in 2020, and is in good condition. The heating and chilled water system in the overall facility is a 4-pipe system, with a capacity for simultaneous heating and cooling operation, which is compliant with the OSDM requirements for basic system type. The overall facility is served by 2 rooftop units, which were installed in 1987 and are in poor to fair condition. The three water tube boilers, manufactured by Thermal Solutions, were installed in 2020 and are in fair to good condition. Heating water / Heated air is distributed to terminal units consisting of unit ventilators, cabinet heaters, unit heaters, and air handlers. The terminal equipment was installed in 1987 and is in fair to good condition. The system appears to comply with the 15 CFM per person fresh air requirements of the Ohio Building Code mechanical code and Ohio School Design Manual. The Automated Logic Analog type system temperature controls were installed in 1987 and are in poor to fair condition. The system does not feature individual temperature controls in all spaces required by the OSDM. The overall system does not feature any central energy recovery systems. The facility is not equipped with louvered interior doors to facilitate Corridor utilization as return air plenums. The existing system is ducted, but the ductwork cannot be integrated into a possible future system due to arrangement, air volume, and routing of existing ductwork. Onsite observations and age of system indicated non-compliance with current SMACNA, UL, NAIMA, NFPA, and ASHRAE ductwork requirements. The Overall heating system is evaluated as being in safe and efficient working order, though long term life expectancy of the existing facility is not anticipated. The existing overall heating system is not compliant with LEED requirements. The structure is equipped with central air conditioning. The site does not contain underground fuel tanks.

Rating: 3 Needs Replacement

Recommendations: Provide new overall Heating, Ventilating, and Air Conditioning systems due to useful lifecycle considerations, varying age and conditions between component parts, and to complete a renovation project with a fully integrated system of unified design to support meeting OBC, OSDM, and LEED requirements. Replace existing ductwork to facilitate efficient exchange of conditioned air.

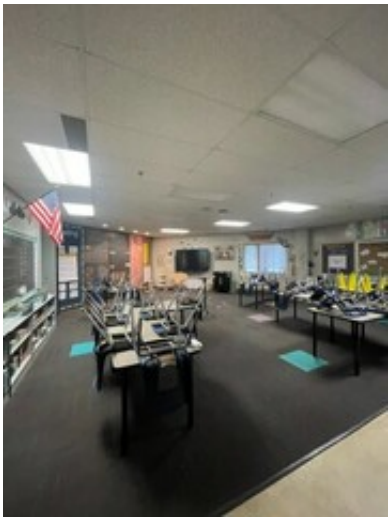
Description: Daylighting strategies, complemented with photo-cell control of lighting fixtures are currently featured in the building's design. The typical Classrooms in the overall facility are equipped with T-8 2x4 lay-in fluorescent fixtures with dual level switching. Classroom fixtures are in good condition, providing an average illumination of 36 FC, which is less than the 40 FC recommended by the OSDM. The Art and Music Rooms in the overall facility are equipped with T-8 2x4 lay-in fluorescent fixtures with single level switching as well as 1x4 indirect suspended fluorescent fixtures with multi level switching. Art and Music Room fixtures are in good condition, providing an average illumination of 40 FC, thus complying with the 40 FC recommended by the OSDM. The Typical Corridors in the overall facility are equipped with T-8 2x4 lay-in fluorescent fixtures with dual level switching. Corridor fixtures are in good condition, providing an average illumination of 14 FC which is less than the 15 FC recommended by the OSDM. The Primary Gymnasium spaces are equipped with T-8 2x4 suspended fluorescent fixtures type lighting, in good condition, providing an average illumination of 14 FC, which is less than the 30 ES FC recommended by the OSDM. The Media Center is equipped with T-8 lay-in 2x4 fluorescent fixture type lighting in good condition, providing an average illumination of 20 FC, which is less than the 30 FC recommended by the OSDM. The Student Dining spaces are equipped with T-8 2x4 lay-in fluorescent fixture type lighting with multi level switching. Student Dining fixtures are in good condition, providing an average illumination of 25 FC, which is less than the 40 FC recommended by the OSDM. The Kitchen spaces are equipped with T-8 1x4 surface mounted fluorescent fixture type lighting with multi level switching. Kitchen fixtures are in good condition, providing an average illumination of 47 FC, which is less than the 50 FC recommended by the OSDM. The Service Areas in the overall facility are equipped with T-8 1x4 suspended fluorescent fixture type lighting in good condition as well as T-8 2x4 lay-in fluorescent fixture type lighting in good condition. The Typical Administrative spaces in the overall facility are equipped with T-8 2x4 lay-in fluorescent fixture type lighting in good condition, providing inadequate illumination based on OSDM requirements. The overall lighting systems of the facility are not fully compliant with Ohio School Design Manual requirements due to inadequate lighting levels.

Rating: 2 Needs Repair

Typical Classroom Lighting

Recommendations: Provide complete replacement of interior lighting system due to lighting levels, installation of systems outlined in Items A, C, D, E, T, U.

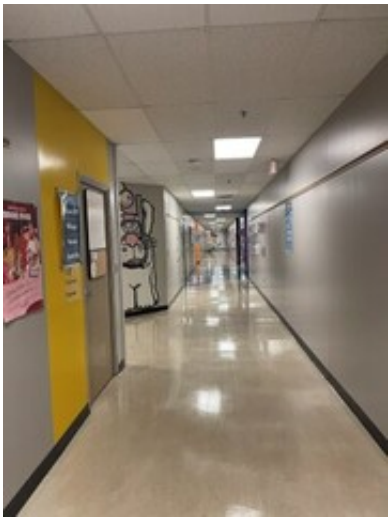
Typical Corridor Lighting

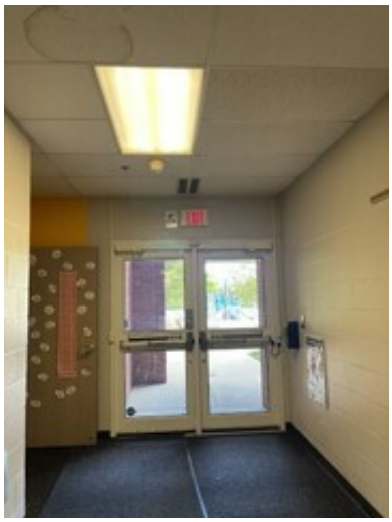
Description: The overall facility is equipped with an emergency egress lighting system consisting of non compliant incandescent, plastic construction exit signs, as well as OSDM compliant red lettered exit signs, and the system is in fair condition. The facility is inadequately equipped with emergency egress floodlighting, and the system is in fair condition. The system is provided with appropriate battery back up and emergency generator. The system is not adequately provided throughout, and does not meet Ohio School Design Manual and Ohio Building Code requirements.

Rating: 3 Needs Replacement

Plast Egress Signs at Auxiliary Entrances

Recommendations: Provide complete replacement of emergency / egress lighting system to meet Ohio School Design Manual and Ohio Building Code guidelines.

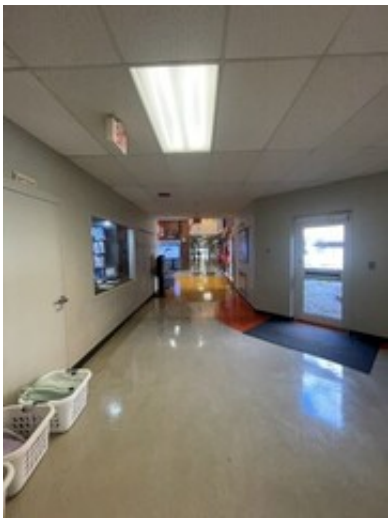
Lack of Egress Flood Lighting throughout School

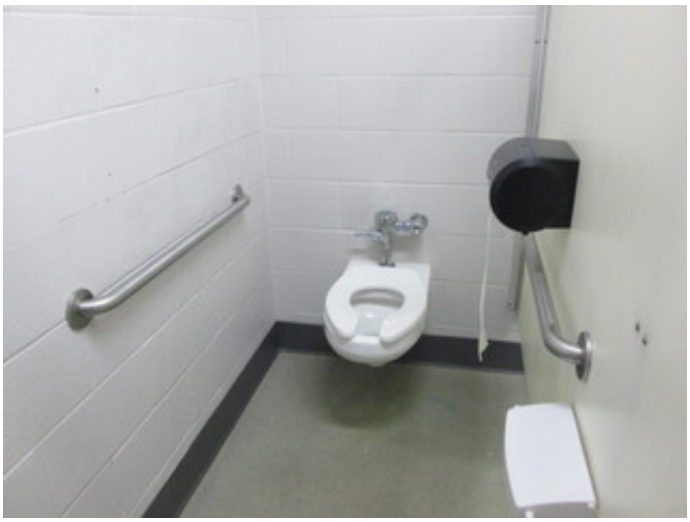
Rating: 3 Needs Replacement

ADA Stall

Non-ADA Drinking Fountain

Recommendations: Provide ADA-compliant signage, 1 power assist door opener, 1 Stage ramp, 4 electric water coolers, 13 toilets, 10 sinks, 13 toilet partitions, toilet accessories in the overall facility to facilitate the school's meeting of ADA requirements. Provide replacement of 5 urinals and 3 sinks. Provide rework of opening and Corridor of 12 doorways. Provide remounting of mirrors.
